Separate Battalions Barracks Complex

Volume IV of IV – Asbestos and Hazardous Waste Material Reports

Building No. 4661 Ft. Bragg, North Carolina

This report documents the supplemental asbestos inspection and survey of Building No.4661 at Fort Bragg, North Carolina conducted on 25 September 2002 by Savannah District US Army Corps of Engineers employees Tim Jones and Jack Ford. The survey was conducted in general accordance with the regulatory guidelines in the Asbestos Hazard Emergency Response Act (AHERA) (40 CFR Part 763 Subpart E Sections 763.80-763.88) and “Guidance for Controlling Asbestos-Containing Materials in Buildings” (Purple Book) (EPA publication number 560/5-85-024). Although not required by the AHERA guidelines, roof and other exterior miscellaneous materials were also inspected and sampled.

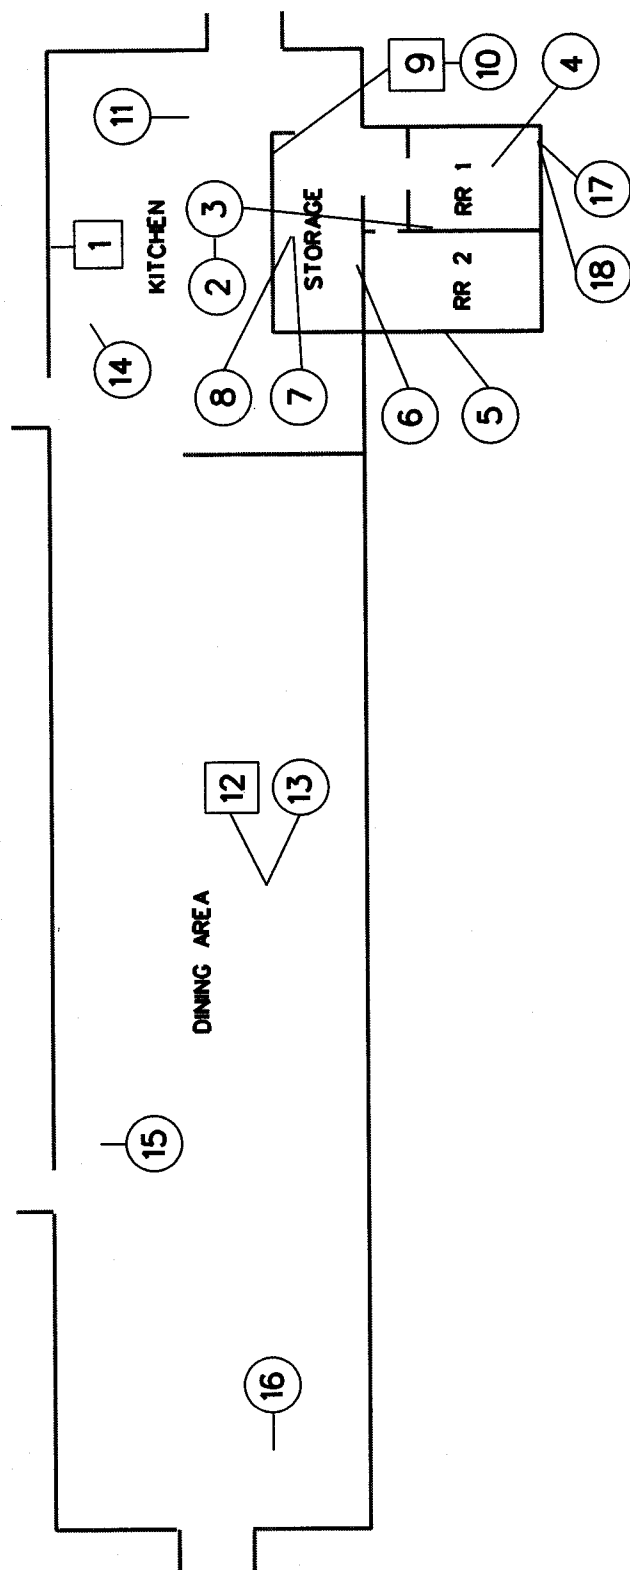
- a. *Roofing Materials:* The roof shingles and felt were sampled and found to be non-asbestos materials. Some remnants of roofing cement were noted on metal roof vents and this cement is assumed to be asbestos containing. – (Refer to Table 1 for specific information and Figure 1 for sample locations).
- b. *Flooring Materials:* 9” X 9” black floor tiles and their associated mastic in the dining area were identified by Law Engineering to be asbestos containing. No

other flooring materials were found to contain asbestos - (Refer to Tables 2 and 3 for specific information and Figure 2 for homogeneous area locations).

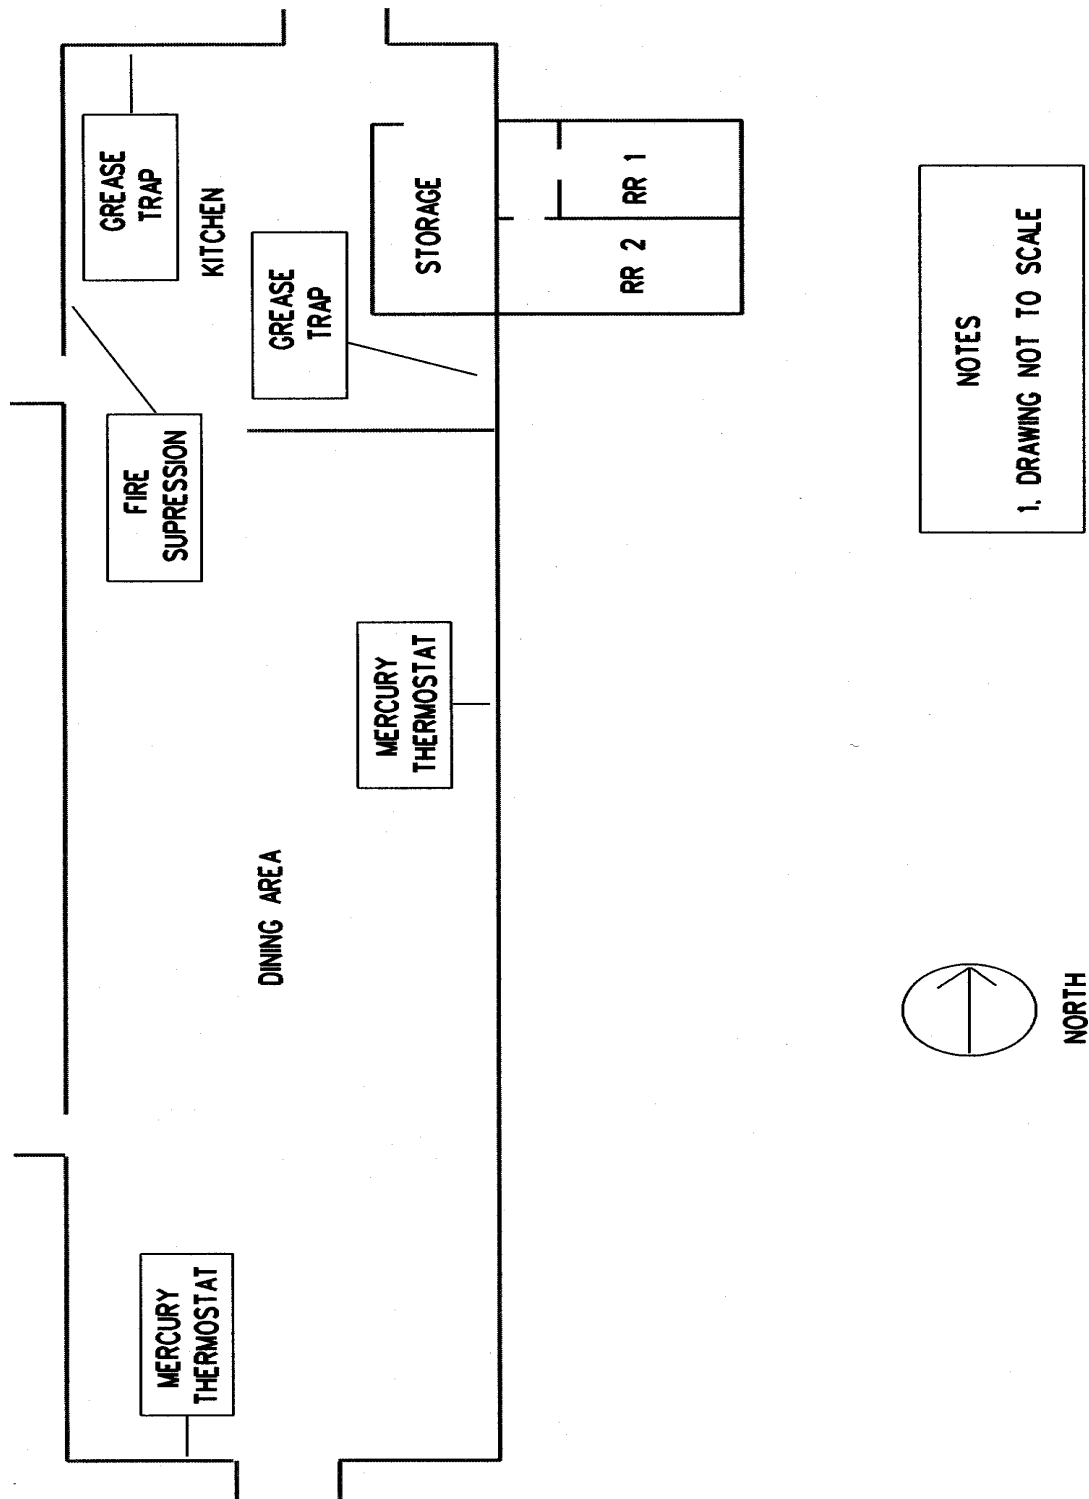
Figure 1

- c. *Grease Traps:* Two above grade grease traps were located inside the building in the kitchen area. Locations are indicated on the floor plan of Figure 1.
- d. *Fire Suppression System:* A fire suppression system including one compressed media bottle containing Sodium Bicarbonate Suppressant and associated piping to the exhaust hood in the kitchen may be considered hazardous. Copies of the MSDS sheet for this suppressant is available from Badger Fire Protection, Inc., 4251 Seminole Trail, Charlottesville, VA 22911, telephone number 800-424-9300 or can be obtained online. A copy is included as Appendix A.
- e. *Compressed Refrigerant Gas:* A walk in cooler is located outside Building 4661 at the northwest corner. This cooler may contain refrigerant gas that should be recovered prior to demolition.

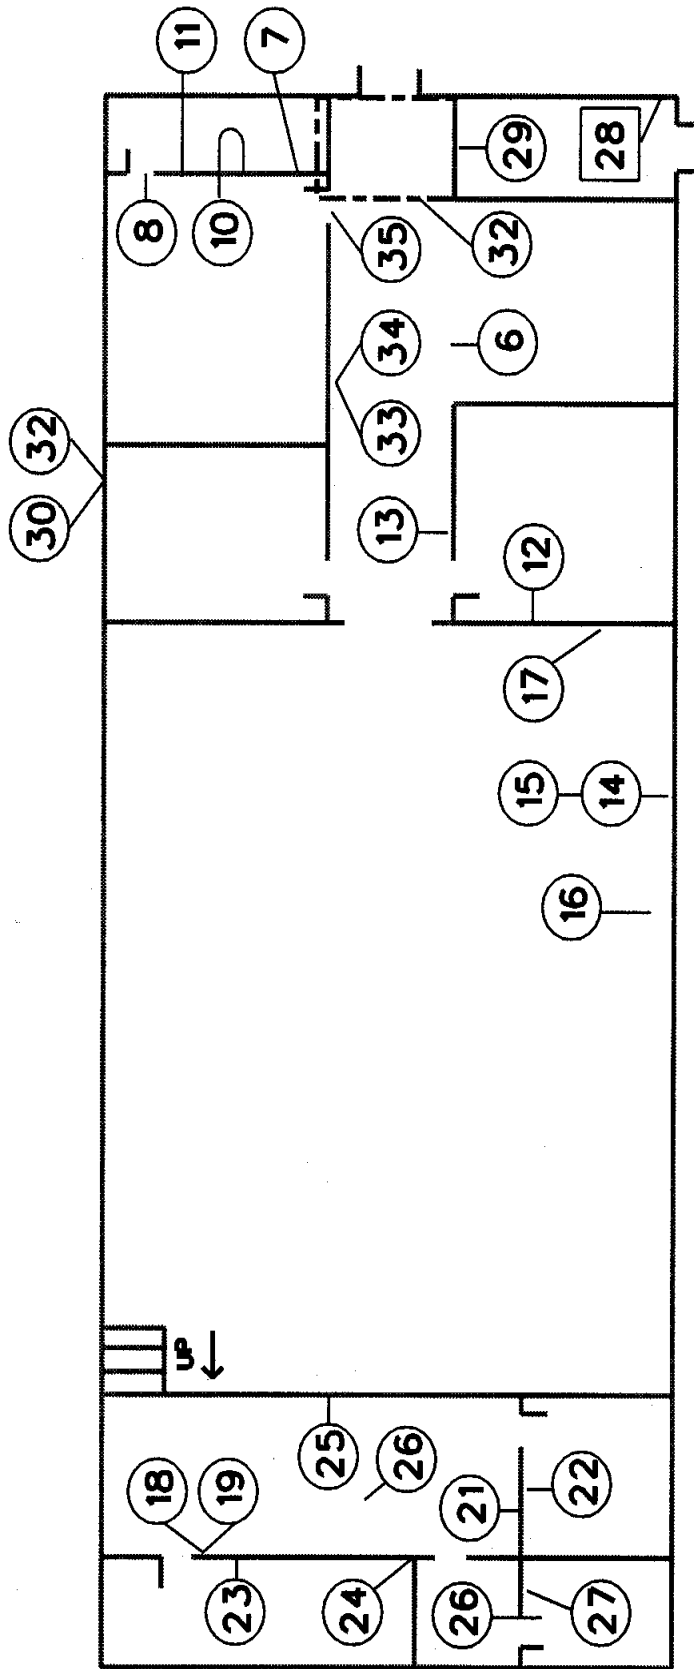
- b. *Flooring Materials:* The mastic associated with the 12" X 12" light blue floor tiles was identified by Law Engineering to be asbestos containing. No other flooring materials were found to contain asbestos - (Refer to Tables 1-3 for specific information, Figure 1 for sample locations and Figure 2 for homogeneous area locations).

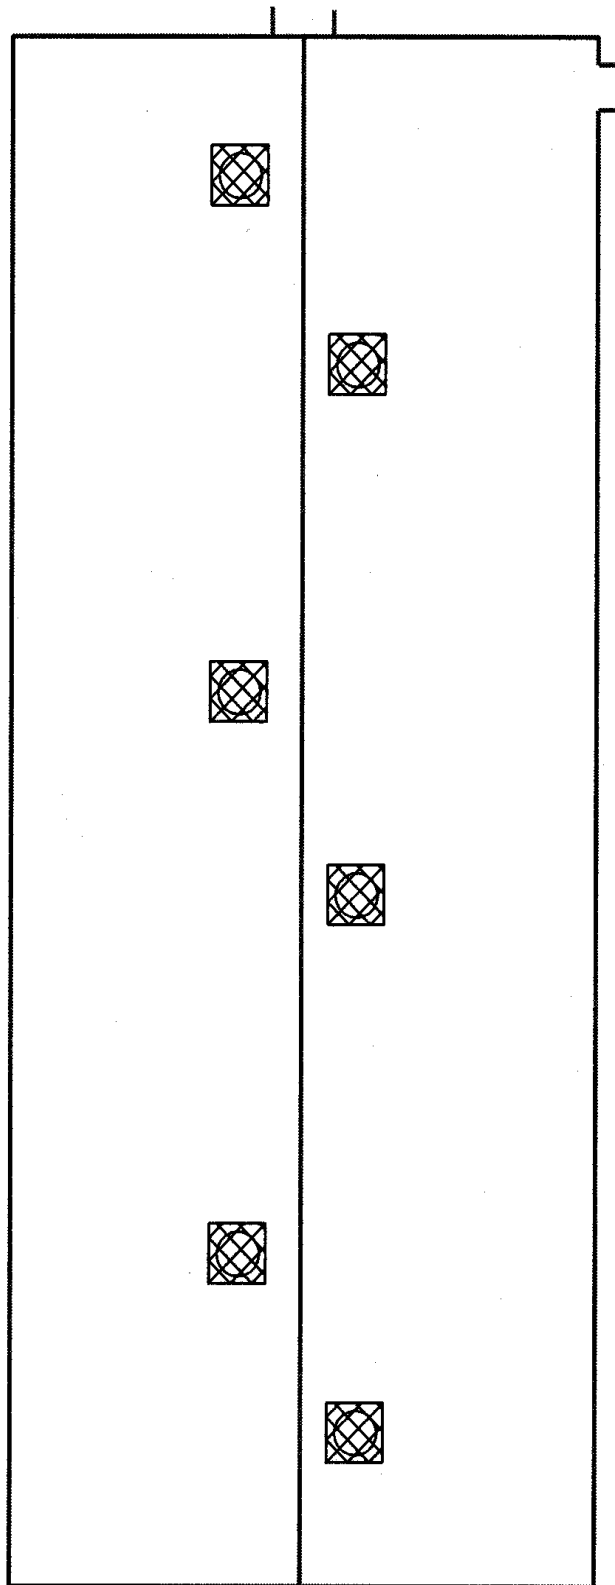
- a. *Roofing Materials:* The roof shingles and felt were sampled and found to be non-asbestos materials. Some remnants of roofing cement were noted on metal roof vents and this cement is assumed to be asbestos containing– (Refer to Tables 2 and 3 for specific information and Figure 3 for homogeneous area locations).

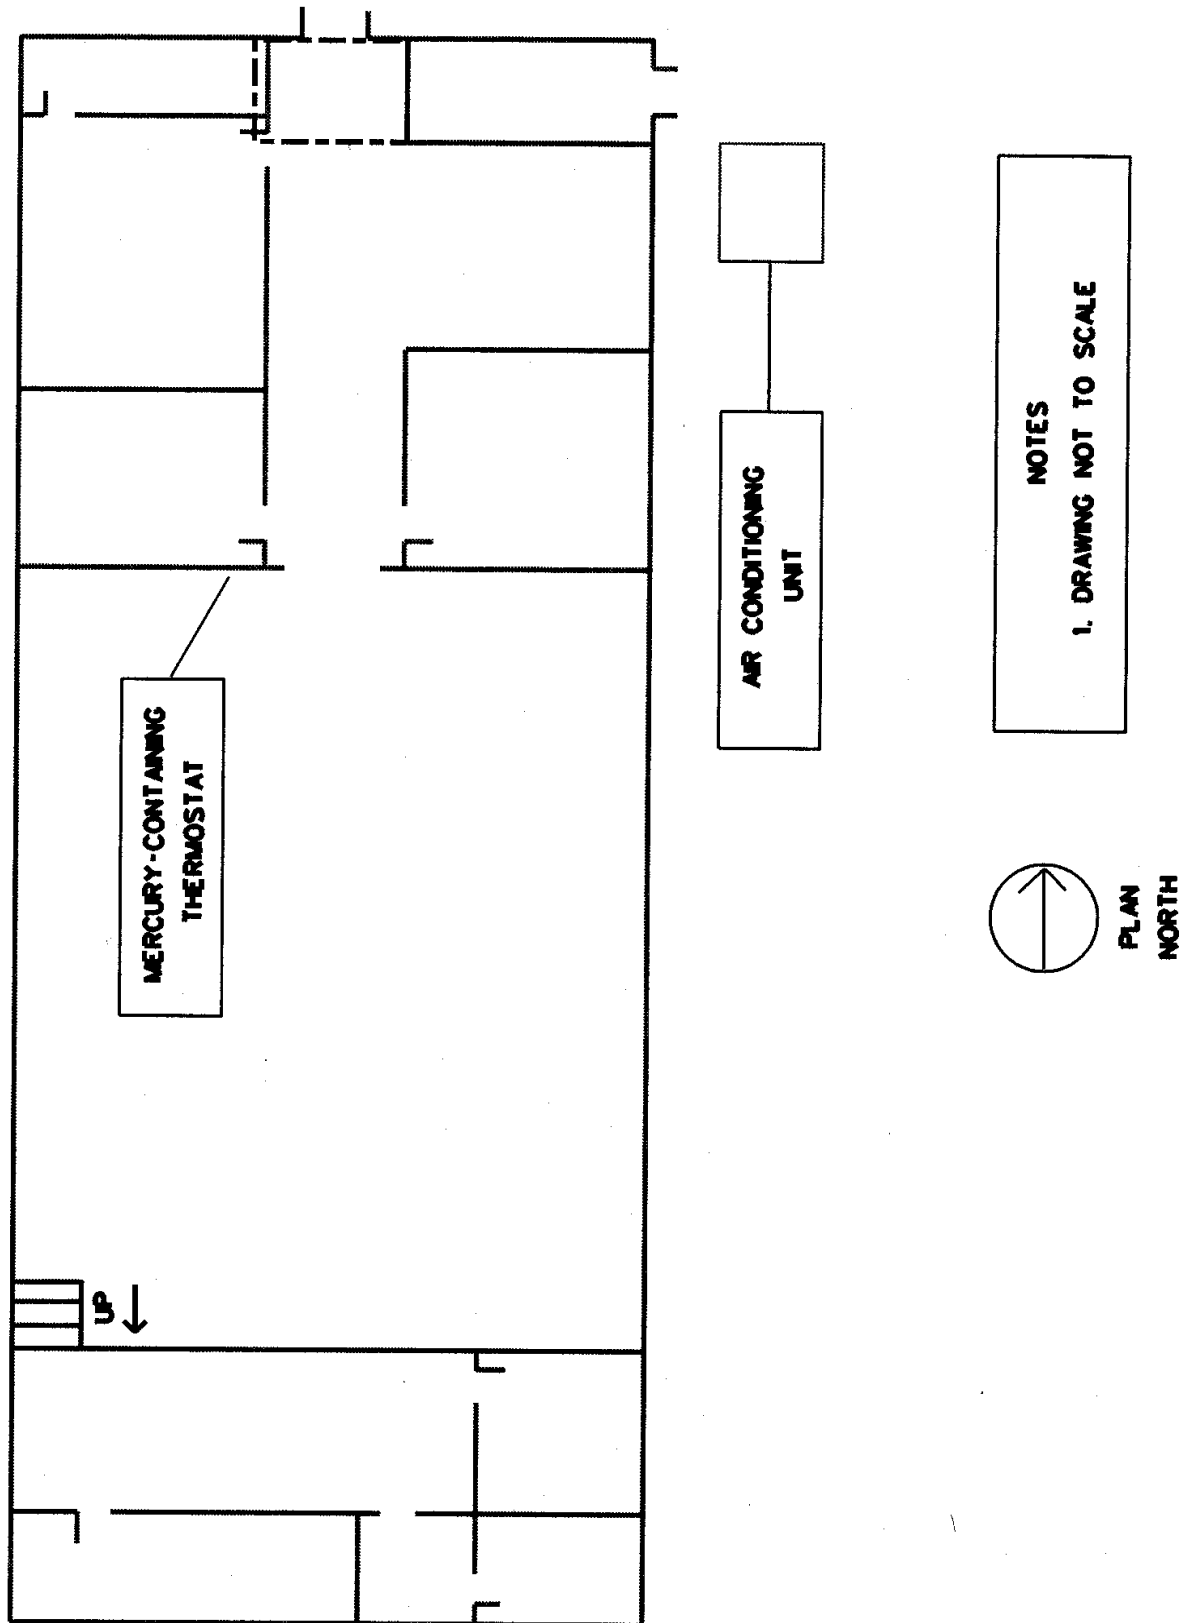
Figure 1

- c. *Thermostats:* One mercury-containing thermostat was located in Building 4662. The Location is indicated on the floor plan of Figure 1.
- d. *Compressed Refrigerant Gas:* Compressed refrigerant gas (freonTM) should be recycled from one central air conditioner and one drinking fountain prior to demolition.
